CHAPTER 20

ROGUES' GALLERY

Lead Author: Frank E. Block, Jr., Clinical Professor of Anesthesiology, Virginia Commonwealth University

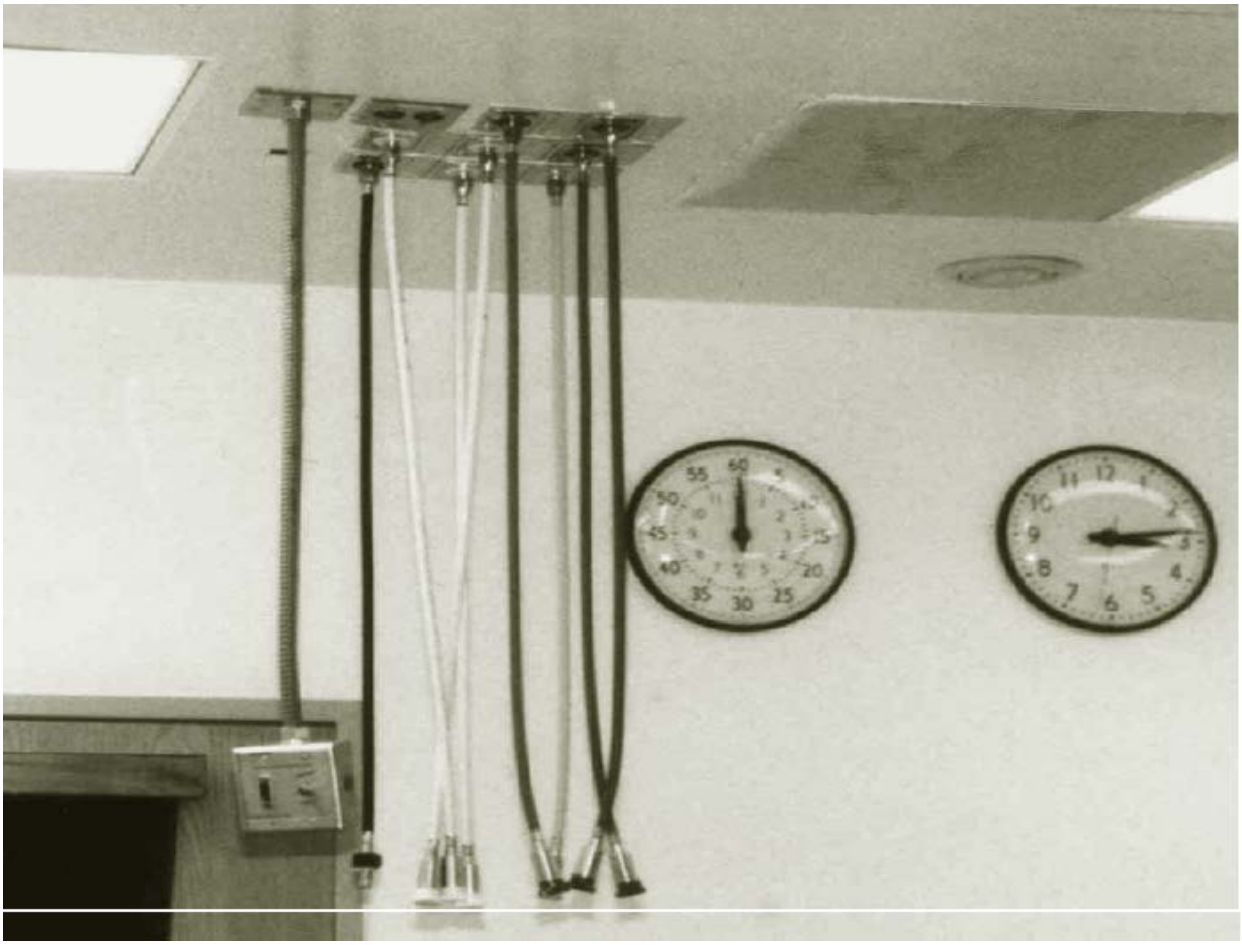
The following picture shows gas drop lines (pigtails) (i.e., hoses) that were positioned in front of the door. They are in the way when patients and equipment are brought into the room. The hoses were supposed to have been located several feet to the right, next to the overhead light.

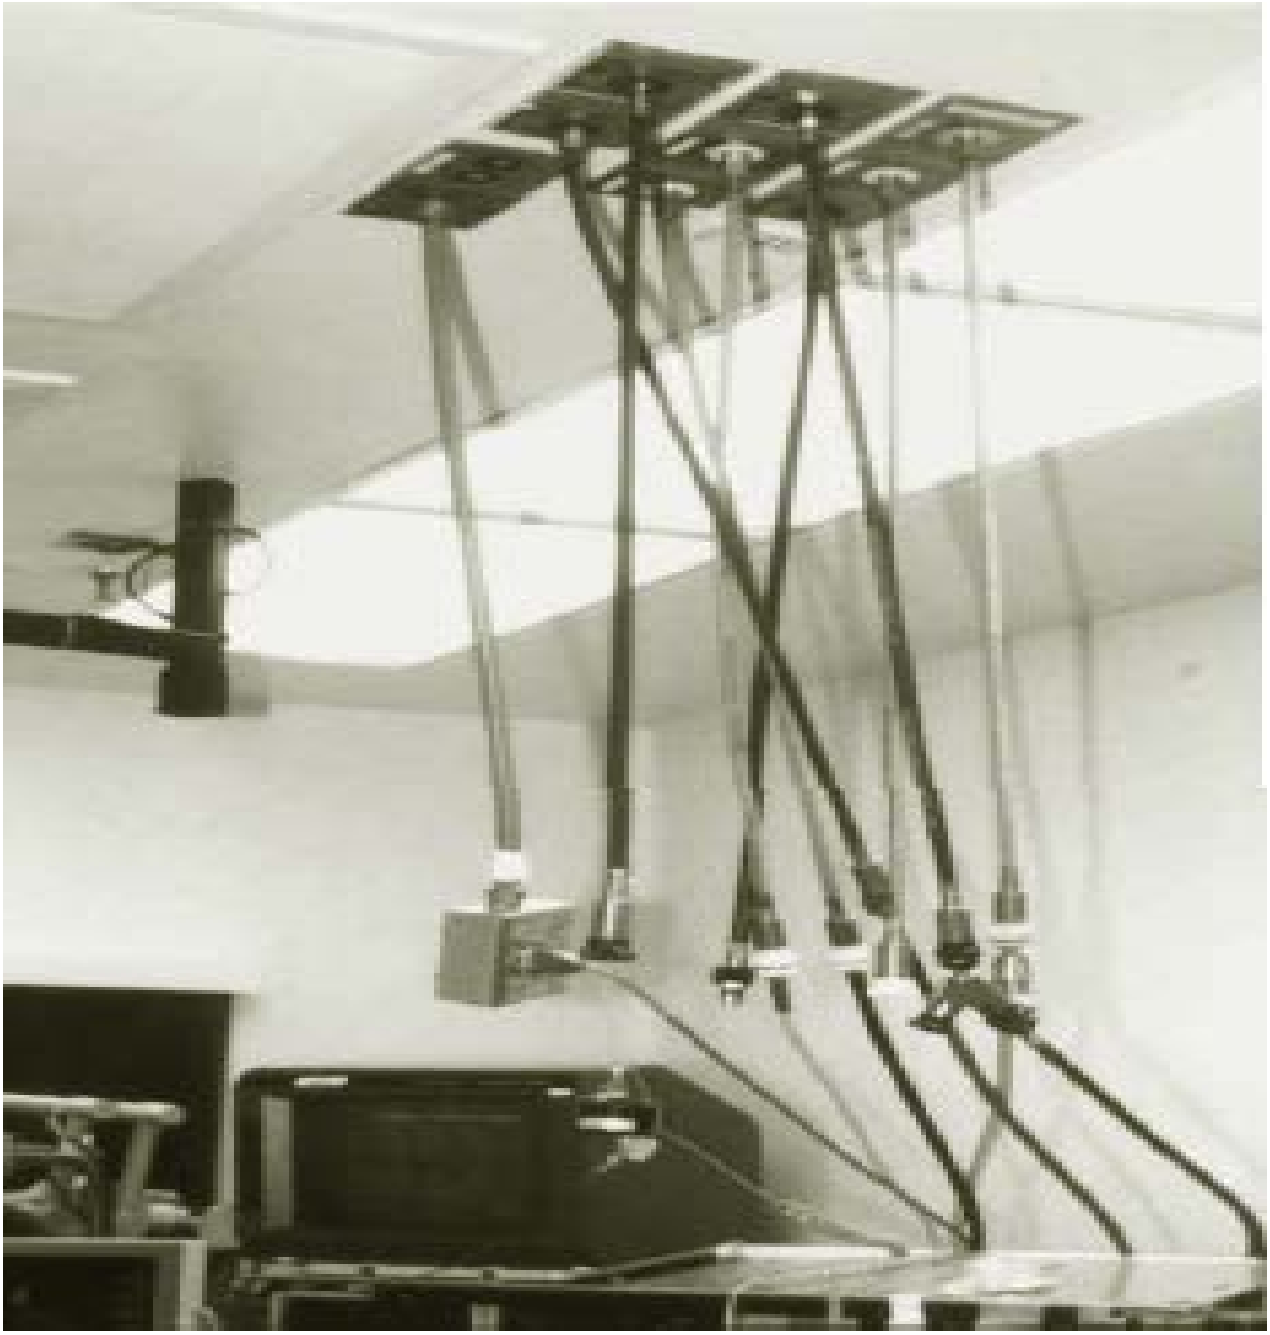
In the next picture, hoses are located directly over the anesthesia machine. This location makes it extremely difficult to move the anesthesia machine, and equipment on top of the anesthesia machine may be displaced by the hoses.
